Maryland Inventory of Historic Properties number: B-4612

Name: CLIPPER MIL RD. OVER JONES FAUS STREAM

MARYLAND INVENTORY OF HISTORIC BRIDGES
HISTORIC BRIDGE INVENTORY
MARYLAND STATE HIGHWAY ADMINISTRATION/
MARYLAND HISTORICAL TRUST

SHA Bridge No. BC 3001 Bridge name Clipper Mill Road over Jones Falls Stream

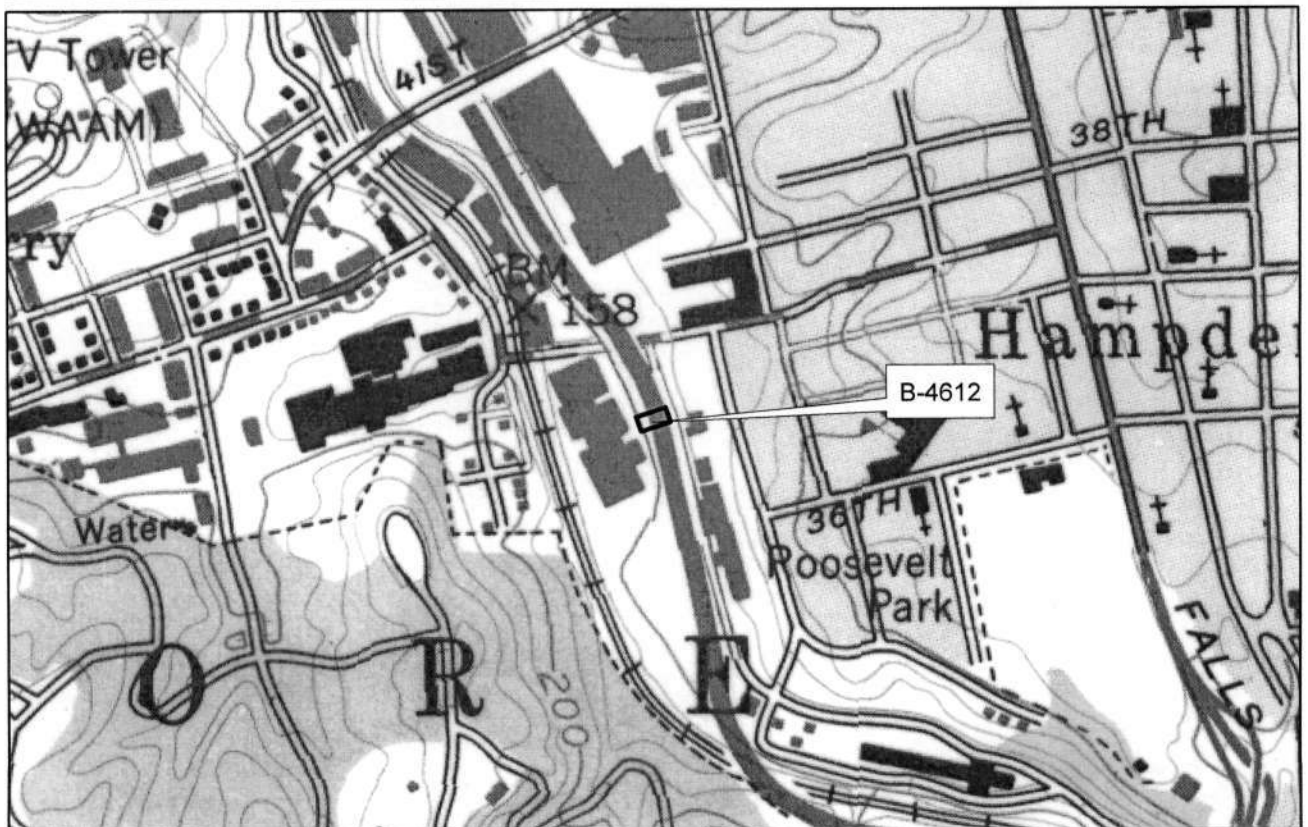
1. B-4612
2. Clippermill D. over Jones Falls Stream
3. Baltimore City (BC 3001)
4. Eric Griffiths
5. 3-97
6. MD SHPD
7. West approach
8. 1-g 6

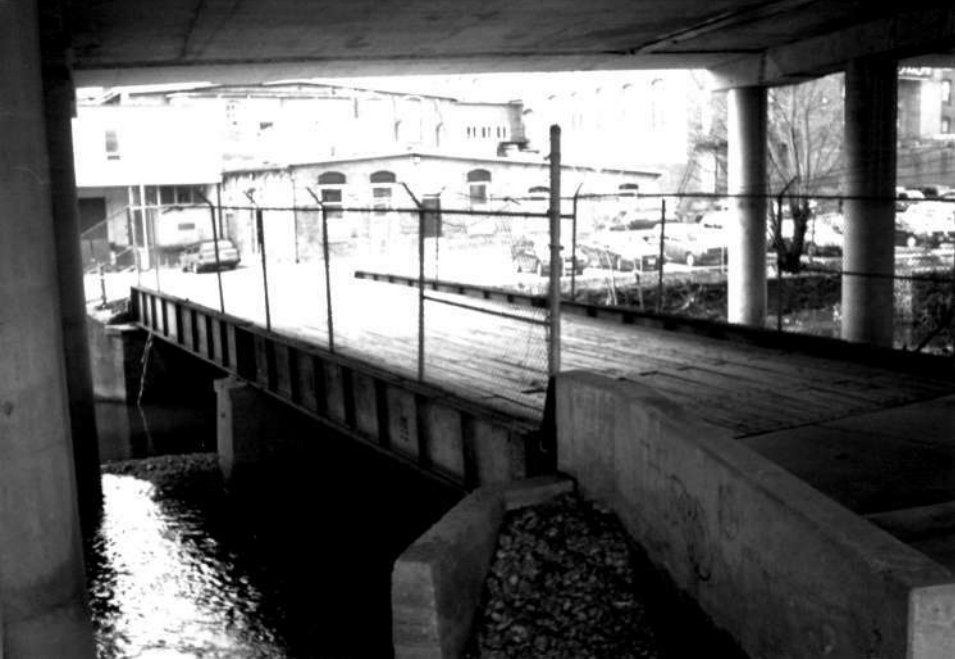
8. 2 of 6

7. South Elevation

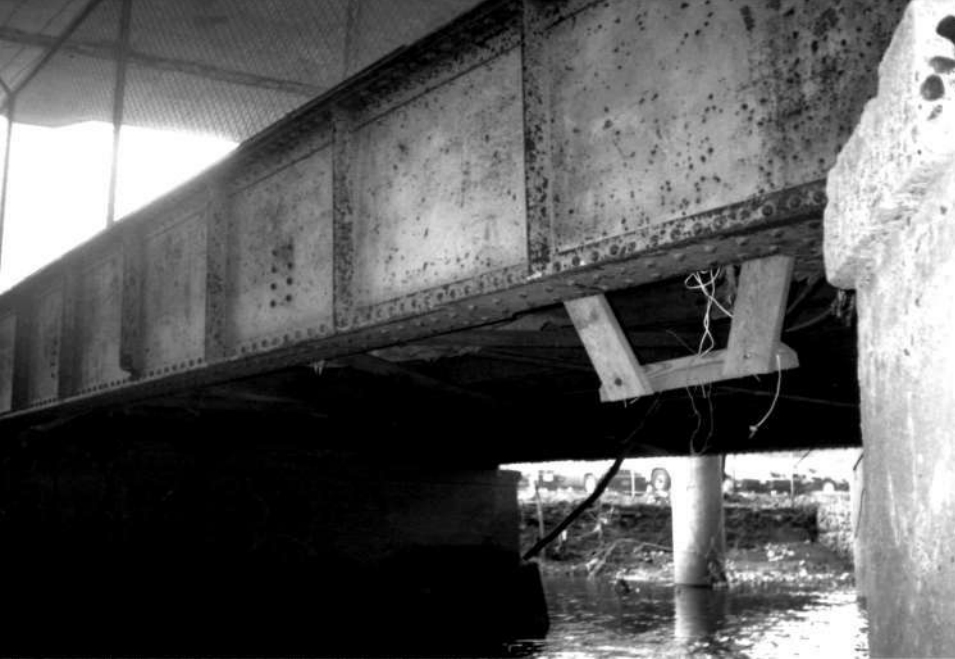
1. B-4612
2. Chipmunk Rd. over Jones Falls Stream
(BC 3001)
3. Baltimore City
4. Eric Hiffitts
5. 3-97
6. MD SHPO
7. Detail of Stringer & Gilder
8. 3 of 6

According to the 1995 inspection report, this structure is in poor condition with the steel plate girders and rolled floorbeams containing corrosion. The timber deck has many areas of splitting and large areas of rot throughout the structure. The concrete has spalling and cracking in the bearing area, and a 1/4-inch wide vertical crack in the center of the east abutment stem. The pier has heavy scaling at the waterline. The chain-link, pedestrian barrier has bent posts and detached rails.

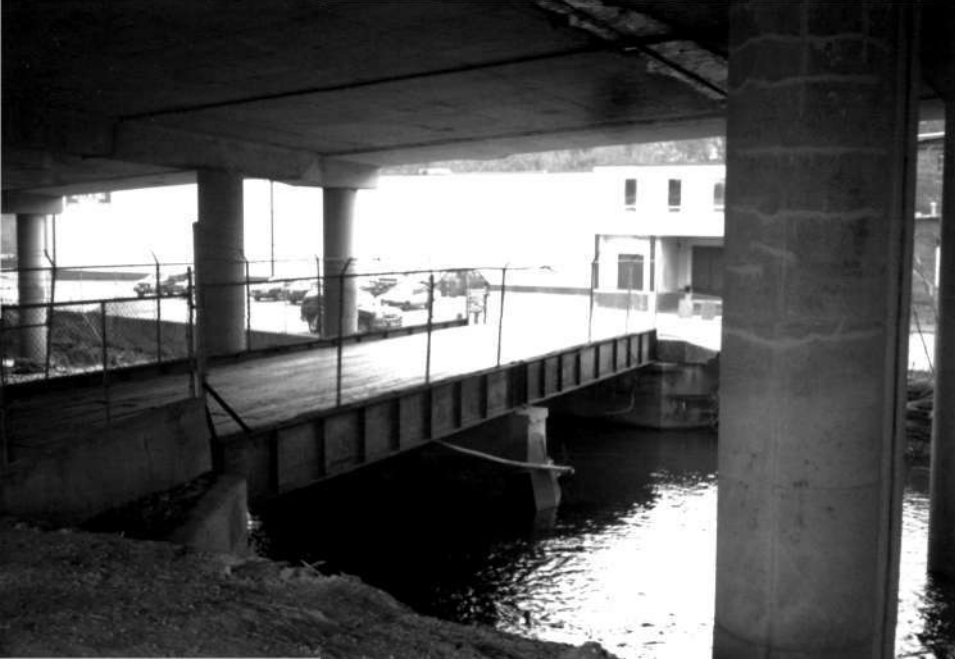
1. B- 4612
2. Chipmunk Bl. 503 Jones Falls Stream
3. Baltimore City (BC 3001)
4. Eric Griffiths
5. 3-97
6. MD SHPO
7. North Elevation
8. 4 of 6

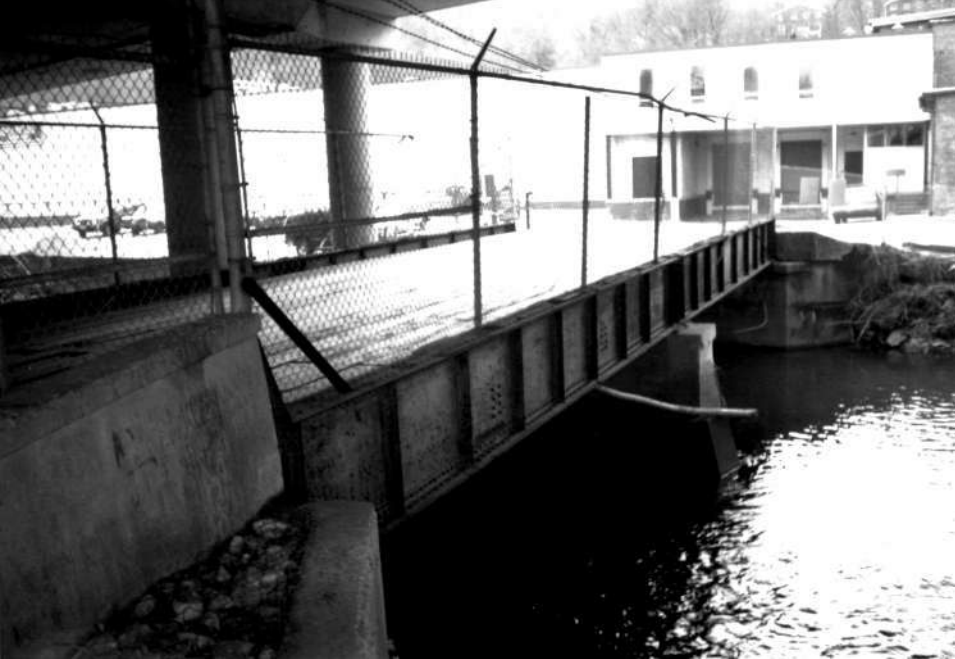
1. B-4612
2. Clippinell Rd. near Jones Falls Stream
3. Baltimore City (BC 3001)
4. Eric Griffiths
5. 3-97
6. MD SHPO
7. North Elevation
8. 5 of 6

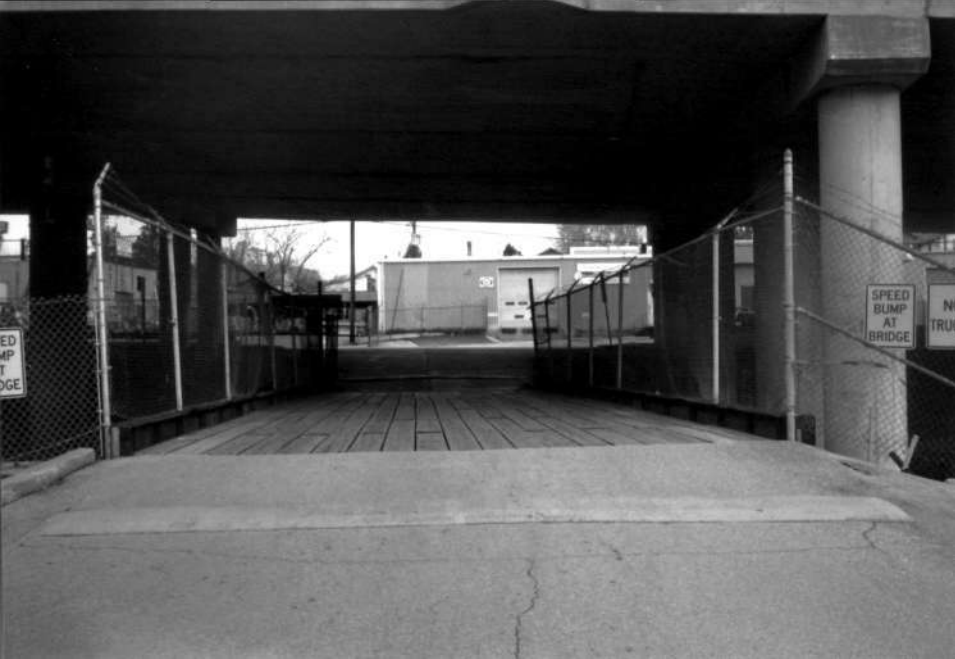
SPEED
BUMP
AT
BRIDGE

1. B-4612
2. Clipperville Rd. near Jones Falls Stream
3. Baltimore City (BC 3001)
4. Eric Huffine
5. 3-97
6. MD SHPO
7. Last Approach
8. 6086
